RESIDENTIAL INSPECTION REPORT

123 Any Street
El Dorado Hills CA 95762

JUNE 15, 2020

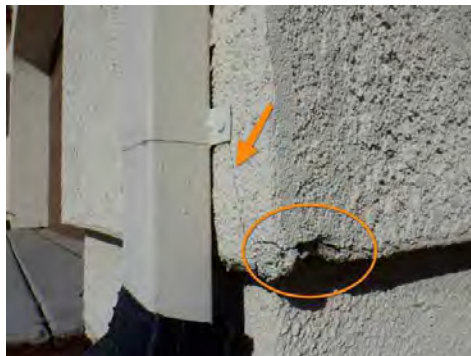
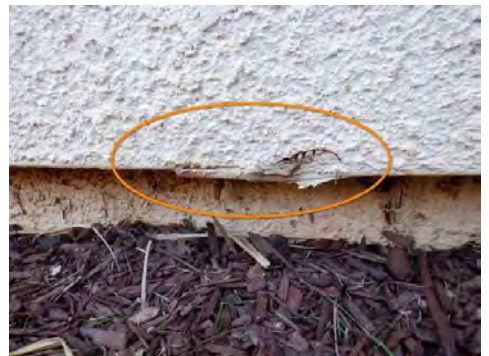
Front Downspout

CRACKING - MINOR

Siding was observed to have minor cracking or other minor damage in one or more places. Some of the cracks were observed at nail holes used to secure the downspouts in place. Other cracks may be a result of temperature changes, and can be typical as homes with stucco age. Recommend repairing any and all missing stucco, sealing all cracks, repainting, and monitoring. If the cracks worsen, then recommend evaluation and repair by a qualified professional.

Contact a stucco repair contractor

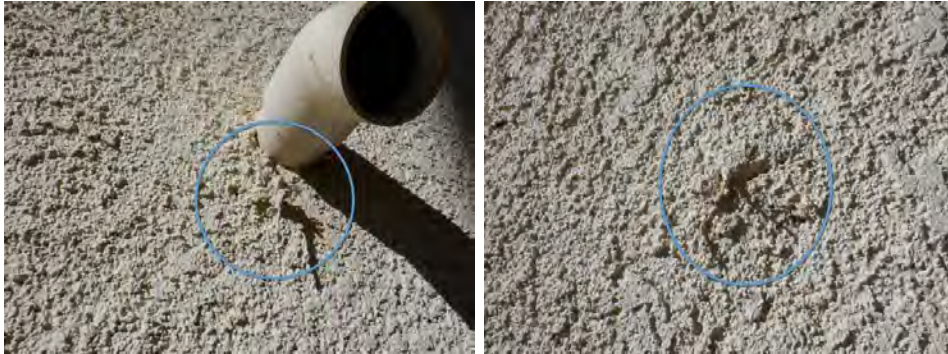
Two Feet Above Garage Occupant Door

2.1.2 Siding, Flashing & Trim

Stucco Wire was observed to be protruding from the wall. While no oxidation ("rust") was observed on the wire, if the wire does later oxidize then the rusting metal may expand and cause cracking of the stucco siding and possible stucco deterioration among other problems associated with water damage. Recommend evaluation and repair by a qualified professional.

Contact a stucco repair contractor

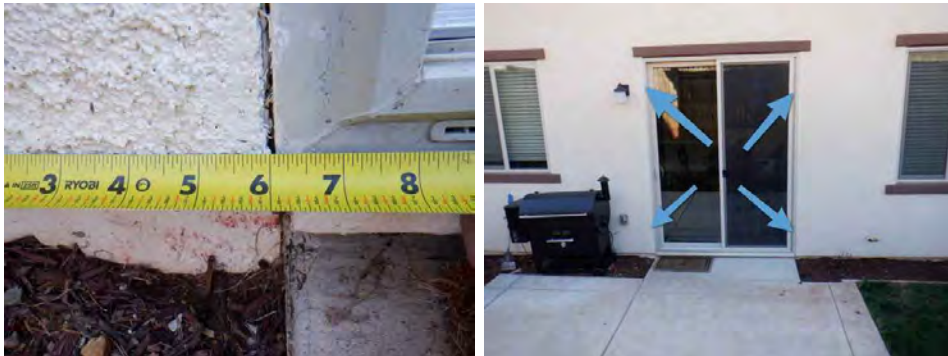
MISSING OR CRACKED CAULKING

Minor cracking or missing caulking was observed. Recommend resealing joint with new caulking and paint.

Contact a handyman or DIY project

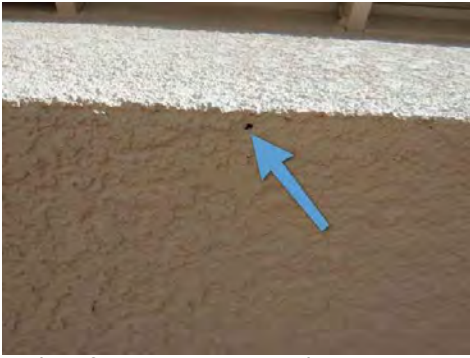
Right of Garage Door, Under Eaves

PEROCITY, DIVETTS, OR HOLES

One or more areas had cavities which were missing wall covering material. It is unknown if these cavities extend through the wall covering and may present the opportunity for water to penetrate the wall covering. It is recommended that these cavities be patched or filled because in these areas water may also collect and over time contribute the water damage which may include wood deterioration. The cavities should be monitored, and if they worsen then recommend evaluation and repair by a qualified professional who specializes in Stucco/EIFS.

Contact a qualified professional.

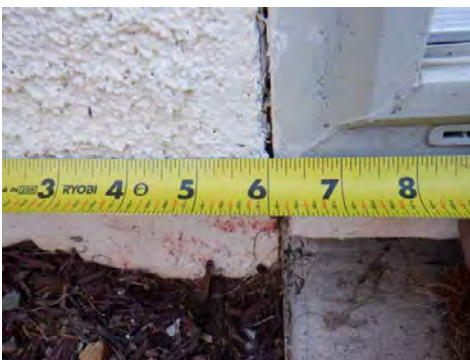
Rear Sliding Door

STUCCO - MISSING "CASING BEAD" AT STUCCO TERMINATION

Casing Bead material was not observed at wall penetrations including windows and doors. With some stucco applications the casing bead may not be required if compatible windows and doors are used with flexible caulking.

If at some time in the future client chooses to upgrade windows and doors, then it is recommended client also consider installing casing bead where the stucco meets these dissimilar materials, and apply caulking to the joints.

Contact a stucco repair contractor

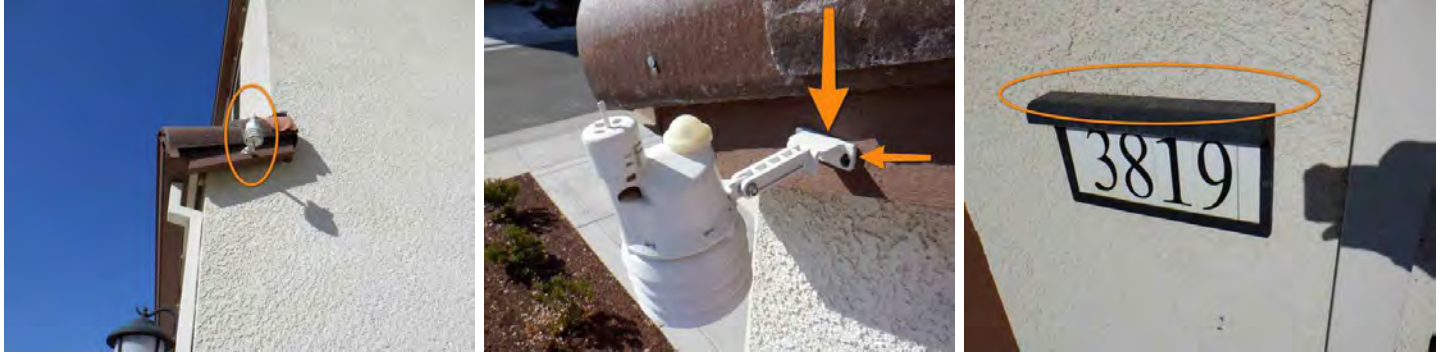
Whenever equipment is attached to siding or trim, applying a flexible and non-shrinking sealant ("caulking") is prudent and necessary to prevent any water intrusion and subsequent deterioration of the siding or trim. Recommend evaluation and application of a sealant by a qualified professional.

Contact a handyman or DIY project

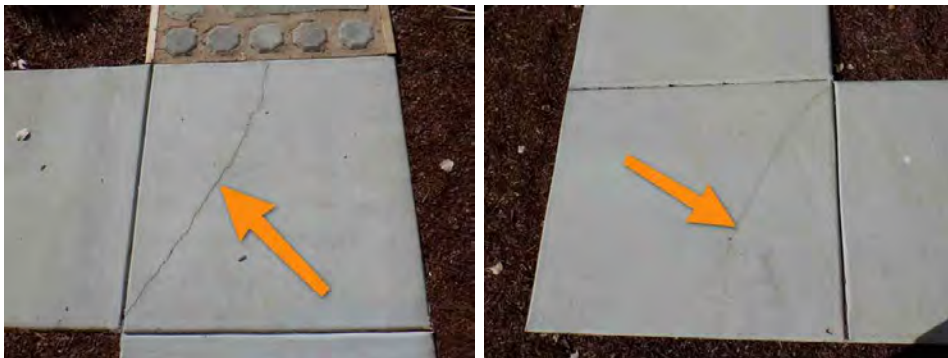
WALKWAY CRACKING - MINOR

Minor cosmetic cracks observed. Recommend monitor and/or patch/seal.

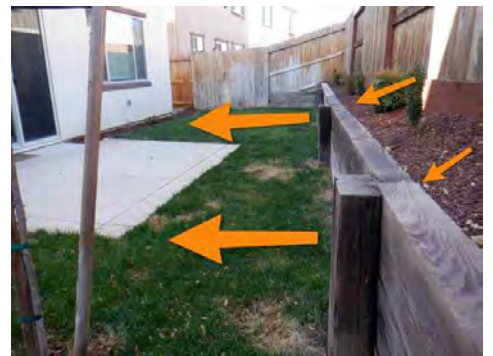
Grading is sloping towards the home in some areas. This could lead to water intrusion and foundation issues. Recommend qualified landscaper or foundation contractor regrade so water flows away from home.

Contact a qualified landscaping contractor

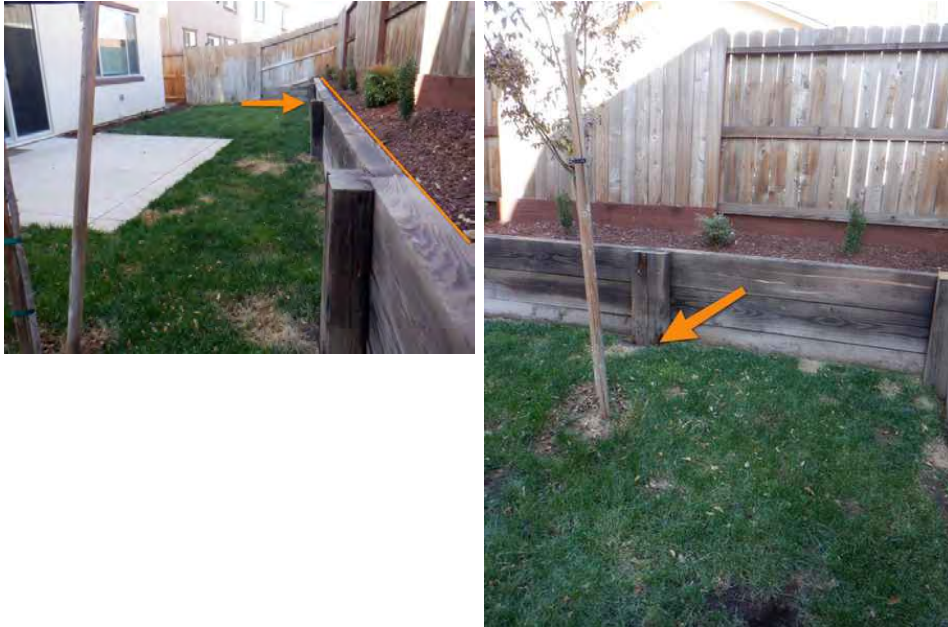
Wood Deterioration

**RETAINING WALL CRACKS**

A retaining wall is present. While the retaining wall was observed to have deviations, indications of structural failure or lateral movement were not observed. **Evidence of wood deterioration was observed** at one or more pile-on support beams. Recommend evaluation and repair by a qualified professional.

Contact a qualified landscaping contractor

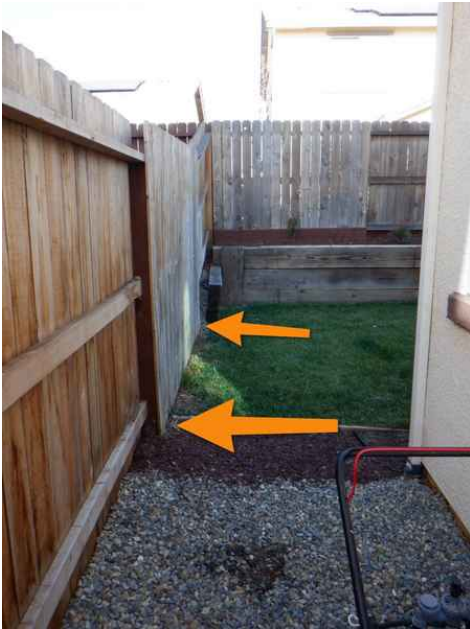
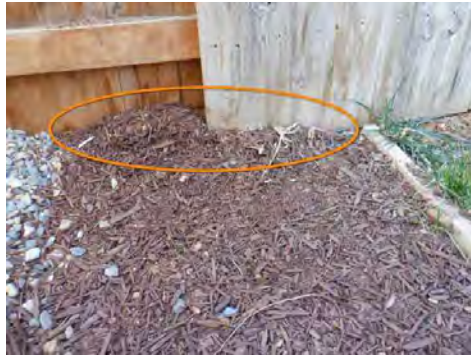
**DIRT OR LANDSCAPING MATERIAL MAY DETERIORATE FENCING**

One or more areas of "wood to earth" contact was noted along the fencing. This can cause excessive moisture and wood deterioration, prematurely shortening the intended service life of the fencing. Recommend removing landscaping debris and unnecessary dirt build-up from posts and other fencing components.

Contact a handyman or DIY project

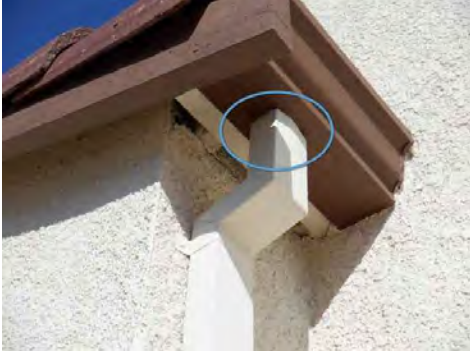
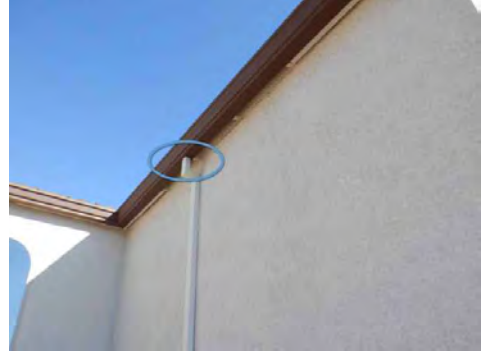
One or more downspout(s) were not properly attached to the gutter. This may contribute to a downspout becoming loose or leaking at the connection with the gutter. Recommend evaluation and repair by a qualified professional.

Contact a qualified gutter contractor

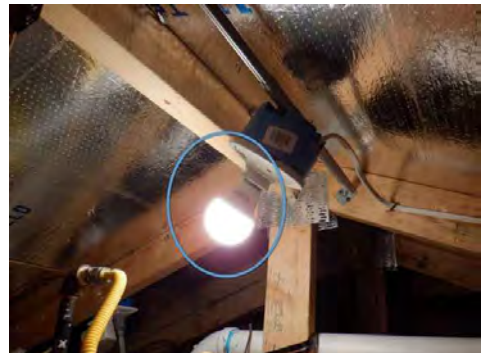
ATTIC

One or more light bulb(s) located in areas which are readily accessible to persons was observed to be unprotected. In that light bulbs are fragile and get hot, unprotected light bulbs create a risk of personal injury by the potential for broken glass or extremely hot surface area if the bulb is broken or touched. A glass globe or cage assembly may be appropriate to protect the bulb(s). Recommend evaluation and repair by a qualified professional.

Contact a qualified handyman.

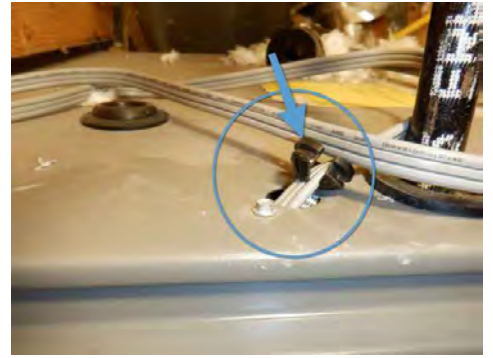
One or more electrical connections had electrical wiring ("conductors") passing through a metal cabinet without adequate protection. This could result in deterioration of the sheathing around the electrical wires, and possible fire or electrocution. Recommend evaluation by a qualified professional.

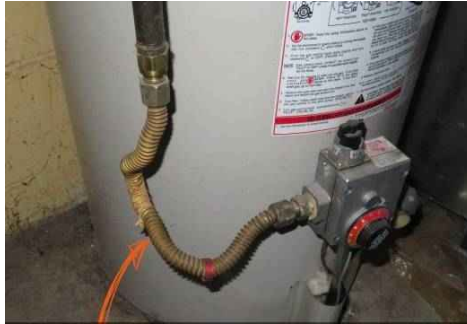
Example of (Outdated) Brass FAC which should be replaced

A Flexible Appliance Connector (FAC) was observed to be used to connect rigid gas supply pipe to one or more gas appliance(s). This is not uncommon and is not a deficiency. Suitable applications of FAC vary based upon manufacturer's specifications. FAC are thin-walled metal and do not provide the same protection as traditional steel piping. FAC also do not protect against lightning strikes which do occur in this region, and are rarely equipped with protective electrical bonding with the gas supply line piping. Pipe doping / thread sealant materials may interfere with electrical bonding continuity and reliability.

Increased care should be observed when handling or installing FAC. FAC should not be kinked or excessively bent, as the thin walls may form a break which allows combustible gas to escape and create a fire hazard. If there is any indication of damage or corrosion seen on the FAC, then the FAC should be replaced by a qualified professional. FAC generally should not be used outside or be exposed to the natural elements, unless explicitly permitted by manufacturer's specifications.

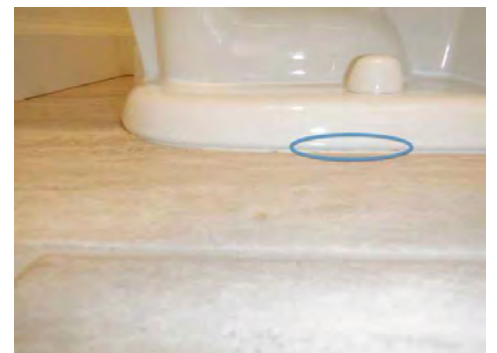
CRACKED CAULKING OR GROUTING

The hallway bathroom toilet was observed to have cracked or missing caulking. This caulking is important to prevent water intrusion under the base of the toilet, and to prevent water damage including but not limited to wood deterioration. Recommend evaluation and repair by a qualified professional.

Note: caulking was present, but had minor cracking, and appeared to be insufficiently applied during installation.

Contact a handyman or DIY project

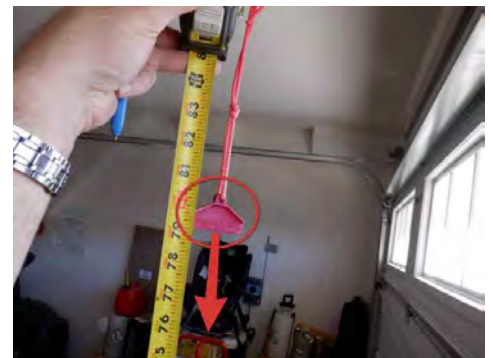
10.5.1 Garage Vehicle Door

In the event of a power failure the garage door may not function and it may become necessary to use the "safety knob" (red handle hanging from the track), to disengage the trolley from the garage door operator's track so that the garage door may be manually lifted up and opened. This red knob is too high, and should be relocated to a height no greater than six (6) feet above the garage floor.

Contact a handyman or DIY project
